## Fire risk assessment

# Riverside House

14 Wharf Street, Swansea. Offices with ground floor café.

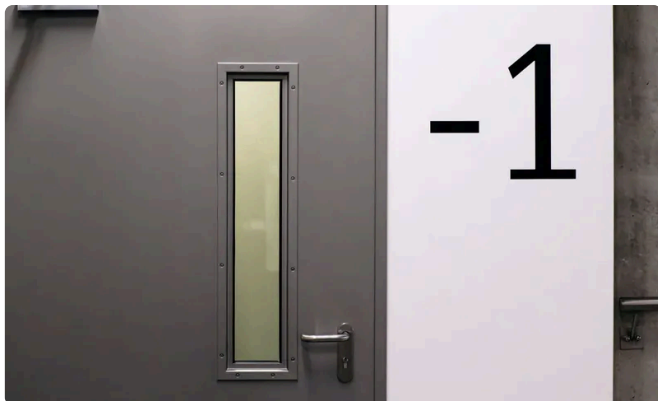
| Ref | Finding | Action | Priority | Target |
|---|---|---|---|---|
| F1 | <b>Fire doors</b><br>The basement stair lobby door did not close fully under its closer. It stopped approximately 8 mm from the frame at the latch side. The intumescent strip and smoke seal appeared intact.<br>Evidence: V5, P6 | Adjust or replace the overhead closer so the door closes fully into its frame and latches from any open position. Check the other stair doors at the same time.<br>Owner: Harbourline Estates | High | 20 Nov 2026 |

P6. Basement stair lobby door, closed position. Basement stair lobby, 10:28.

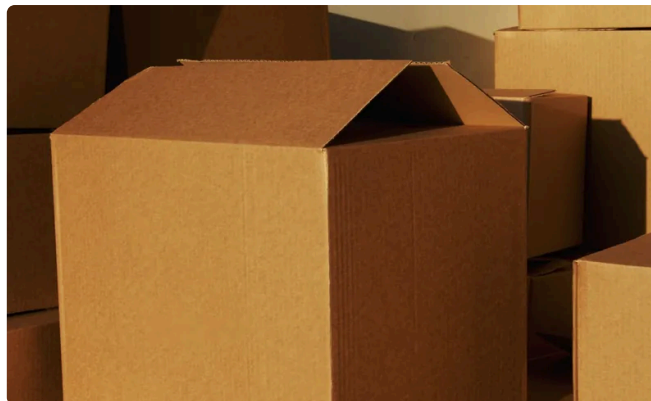
| Ref | Finding | Action | Priority | Target |
|---|---|---|---|---|
| F2 | <b>Housekeeping</b><br>Cardboard boxes and two office chairs were stored against the boiler in the basement plant room.<br>Evidence: V4, P4, P5 | Remove the stored cardboard and furniture and keep the plant room clear. Add the plant room to the weekly walk-round.<br>Owner: Harbourline Estates | High | 27 Oct 2026 |

P4. Stored cardboard in the plant room. Basement plant room, 10:21.

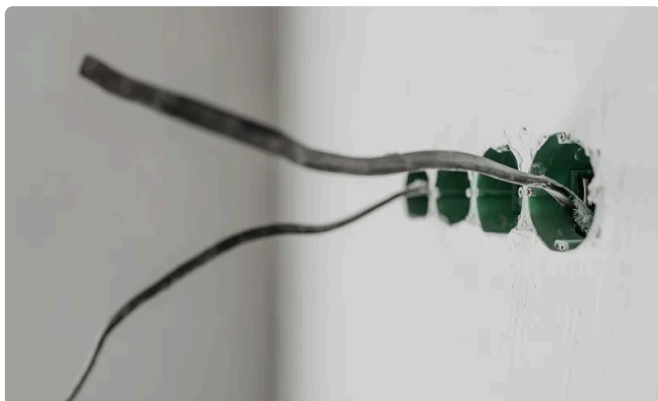
| Ref | Finding | Action | Priority | Target |
|---|---|---|---|---|
| F3 | <b>Compartmentation</b><br>Three cable penetrations of roughly 40 mm passed from the third floor riser cupboard into the adjoining office without fire stopping.<br>Evidence: V8, P9 | Appoint a competent fire-stopping contractor to seal the penetrations with a tested system suited to the wall construction, and keep a record of the products used.<br>Owner: Harbourline Estates | High | 20 Nov 2026 |

P9. Unsealed cable penetrations, third floor riser. Third floor riser, 11:03.

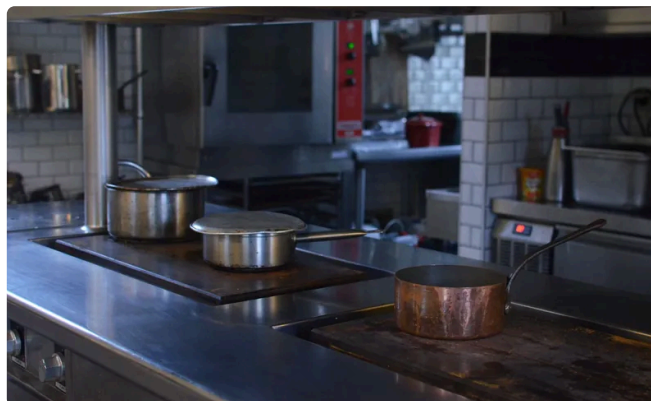
| Ref | Finding | Action | Priority | Target |
|---|---|---|---|---|
| F4 | <b>Fire-fighting equipment</b><br>The wet chemical extinguisher next to the fryer carried a service label dated March 2025 and is overdue for its annual service. The fire blanket was in date.<br>Evidence: V3, P3 | Have the extinguisher serviced by a competent person and confirm the annual service of all extinguishers in the building.<br>Owner: Café tenant | Medium | 20 Nov 2026 |

P3. Café kitchen cooking line. Café kitchen, 10:05.

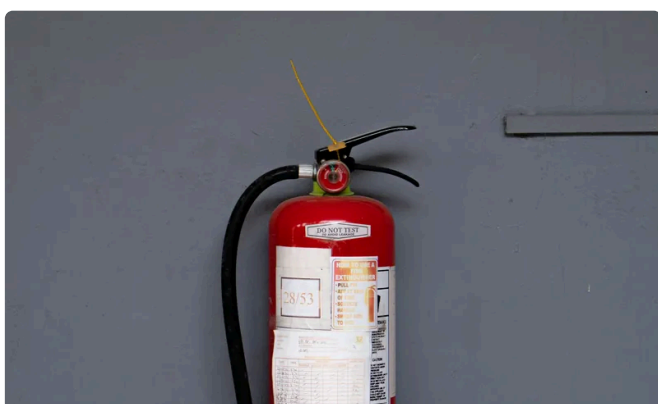
| Ref | Finding | Action | Priority | Target |
|---|---|---|---|---|
| F5 | <b>Fire-fighting equipment</b><br>A CO2 extinguisher was standing on the floor outside the café. It was not on a bracket and there was no sign at the fire point.<br>Evidence: V2, P2 | Mount the extinguisher on a bracket at the fire point and fit a sign above it.<br>Owner: Harbourline Estates | Low | 20 Jan 2027 |

P2. CO2 extinguisher on the floor outside the café. Ground floor corridor, 09:53.

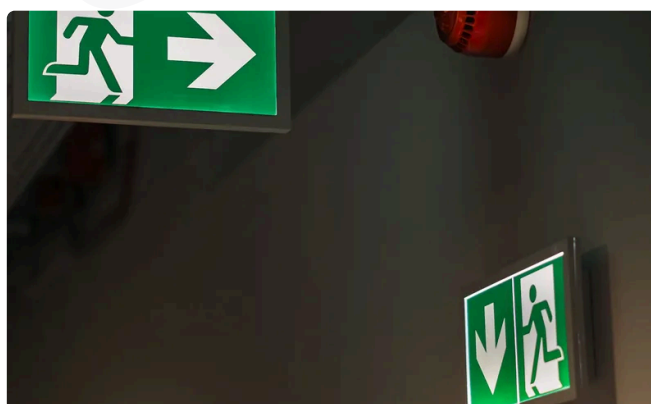
**Means of escape.** First floor corridor and both stairs clear, signage in place and lit. West stair lobby door closes and latches. Evidence: V6, P7, V7, P8, V10.

P7. Exit signage, first floor corridor. First floor corridor, 10:42.
